LAKE SABULA DAM

NDI I.D. NO: PA-425

PHASE I INSPECTION REPORT  
NATIONAL DAM INSPECTION PROGRAM

D'APPOLONIA CONSULTING ENGINEERS

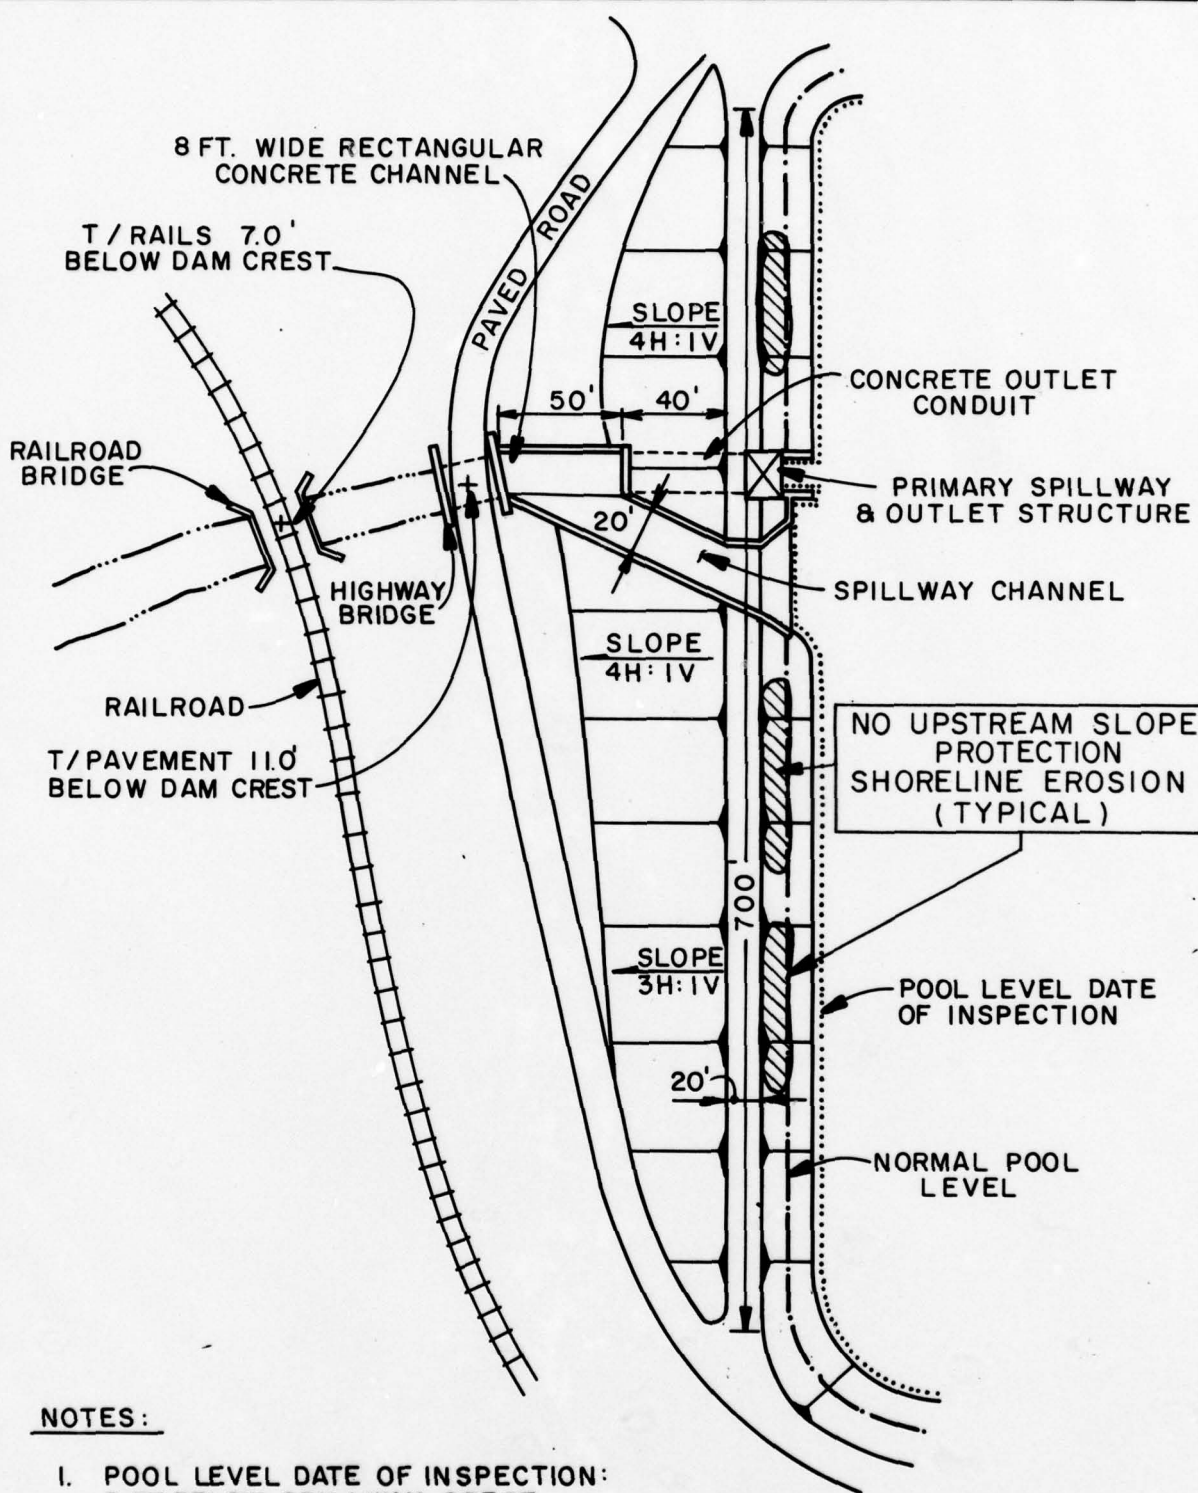
PLATE 2

The specific observations are illustrated in Plate 2 and in the photographs in Appendix C.

1. POOL LEVEL DATE OF INSPECTION: 5 FT. BELOW SPILLWAY CREST
2. SPILLWAY FREEBOARD = 2.5 FT.

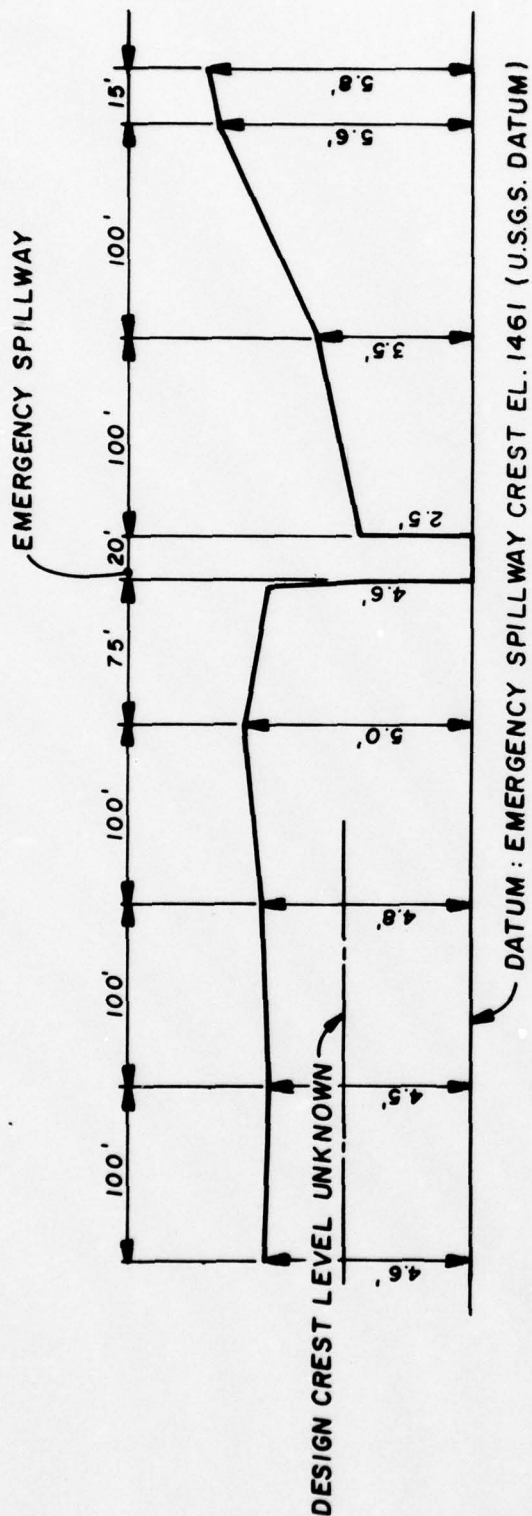
# **DAM CREST PROFILE** (LOOKING DOWNSTREAM)

The crest of the dam was surveyed relative to the emergency spillway crest level. Freeboard was found to range from 2.5 feet on each side of the emergency spillway to 5.8 feet near the right abutment. The dam crest profile is illustrated in Plate 3.
